MEMPHIS LAKE AND PARK DAM
SCOTLAND COUNTY, MISSOURI
MO 10217

PHASE I INSPECTION REPORT NATIONAL DAM SAFETY PROGRAM

Name of Dam: Memphis Lake and Park Dam, Inv. No. 10217
State Located: Missouri
County Located: Scotland
Stream: Tributary of the North Fabius River
Date of Inspection: September 28, and October 5, 1978

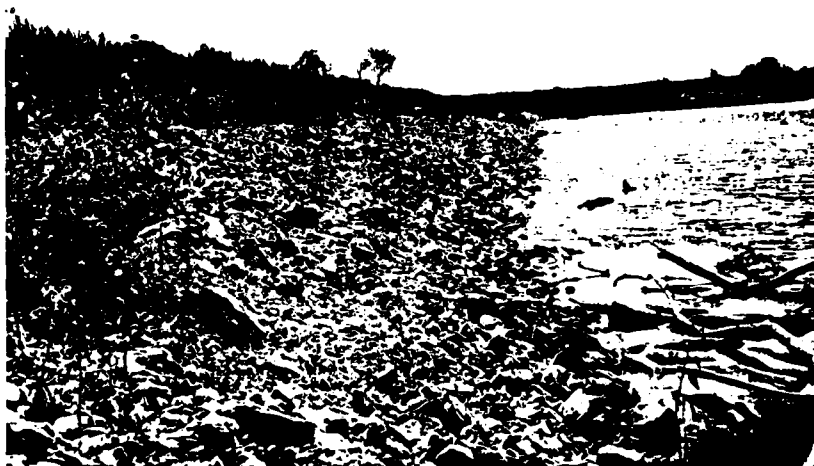
The upstream embankment slope is adequately protected by the riprap described earlier. No degradation due to weathering of the blocks was seen. The riprap appears to be smaller than desirable, but no significant settlement or sloughing of the rock was observed during the inspection. The upstream slope above the riprap limit of the riprap is adequately protected by heavy vegetative cover.

Photo 3 - View of upstream slope of dam taken from slope at left abutment.

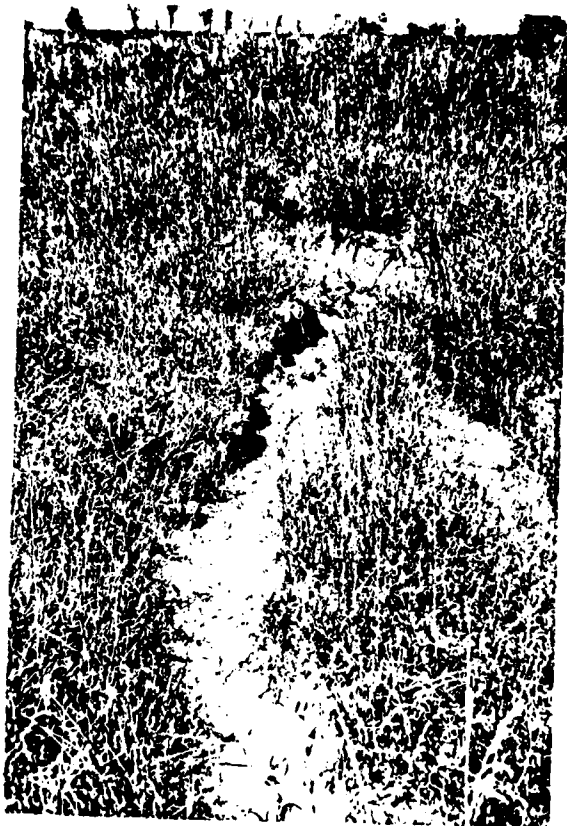
The downstream embankment slope is covered with heavy grass vegetation. Along each abutment contact are relatively large surface erosion gullies. Some of these gullies are 3 to 4 feet deep by 2 feet wide. These gullies are very large for a dam as new as this structure, and repairs should be made to reduce the erosion.

Photo 5 - Picture of erosion gullies in downstream slope along left abutment contact.

The surface erosion gullies should be repaired within a reasonable period of time to prevent the removal of large amounts of embankment material.

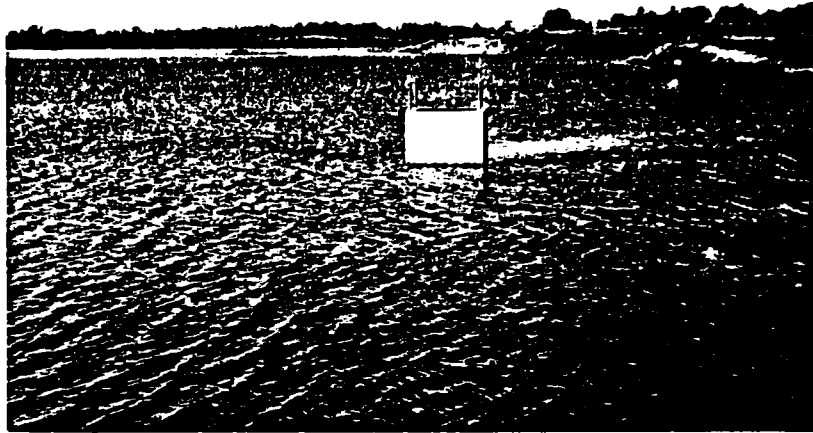
The top of the tower for the water supply outlet was visible. It was observed to be in good and essentially "new" condition. The discharge end of the pipe was not found.

Photo 7 - Picture of intake structure for water supply piping.

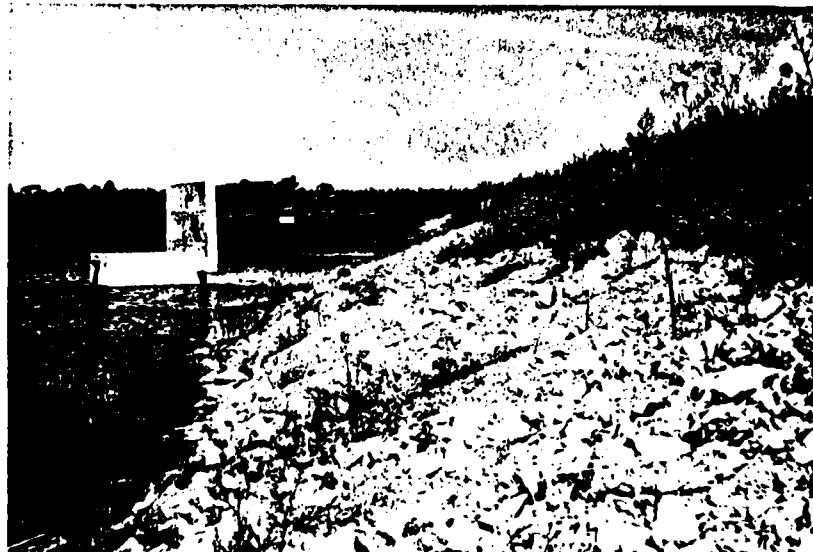
The concrete drop inlet structure is in excellent condition with the exception that there are no provisions for trashracks on the concrete crest. No evidence of structural cracking or spalling could be found. No leakage in the 60-inch C.M.P. was detected. The stilling basin at the end of the 60-inch C.M.P. is also in a good condition, with adequate riprap protection.

Photo 8 - Picture of drop inlet structure for service spillway.

5. Provide a trashrack over the drop inlet of the service spillway.
6. Uncover the buried discharge ends of the low level outlet and the water supply outlet.
7. Seepage and stability analyses should be performed by a professional engineer experienced in the design and construction of dams.

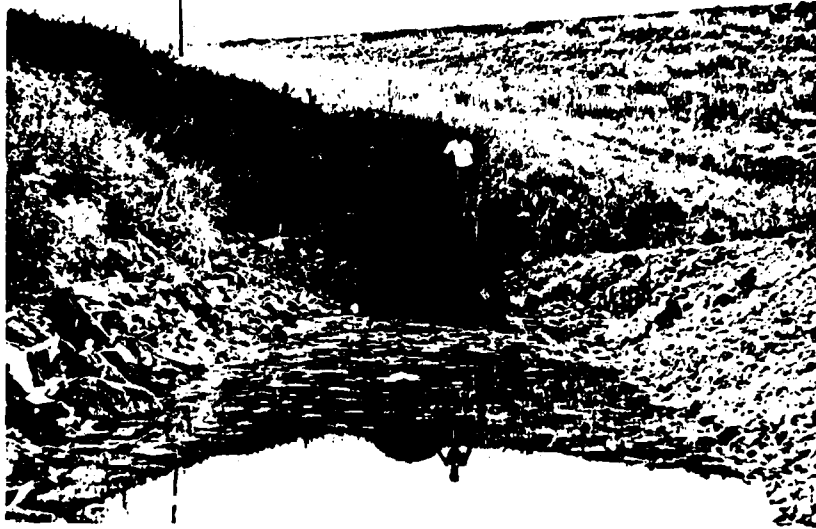
Photo 9 - Picture of discharge end of 60-inch I.D. corrugated metal pipe used for service spillway.

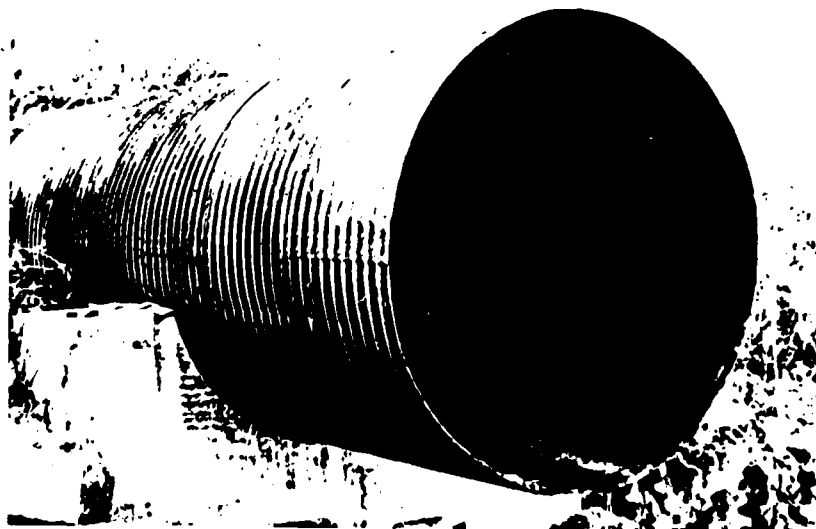
Photo 10 - Close-up of discharge end of 60-inch I.D. corrugated metal pipe.

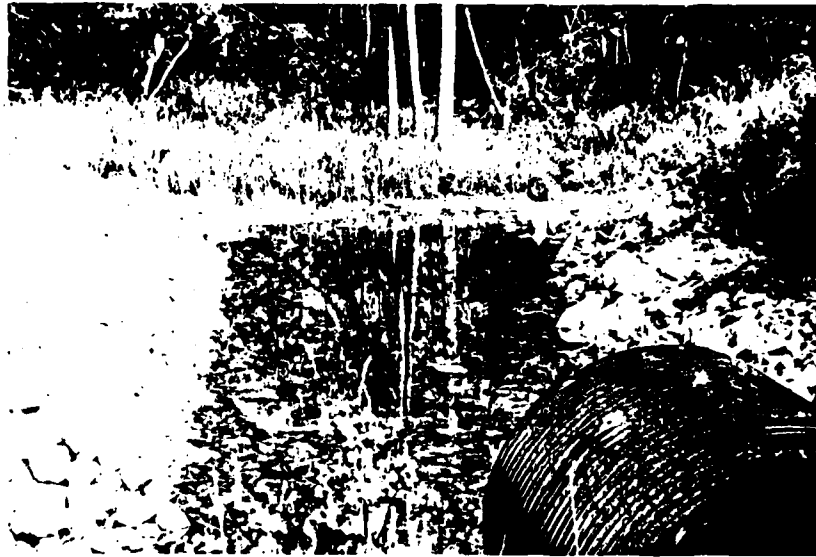
Photo 11 - View of discharge channel for service spillway.
